Flood Investigation Report

Otter Valley Floods 9 May 2023

(Including all reported flooding within the County on this date)

This flood investigation report has been produced by Devon County Council as a Lead Local Flood Authority under Section 19 of the Flood and Water Management Act 2010.

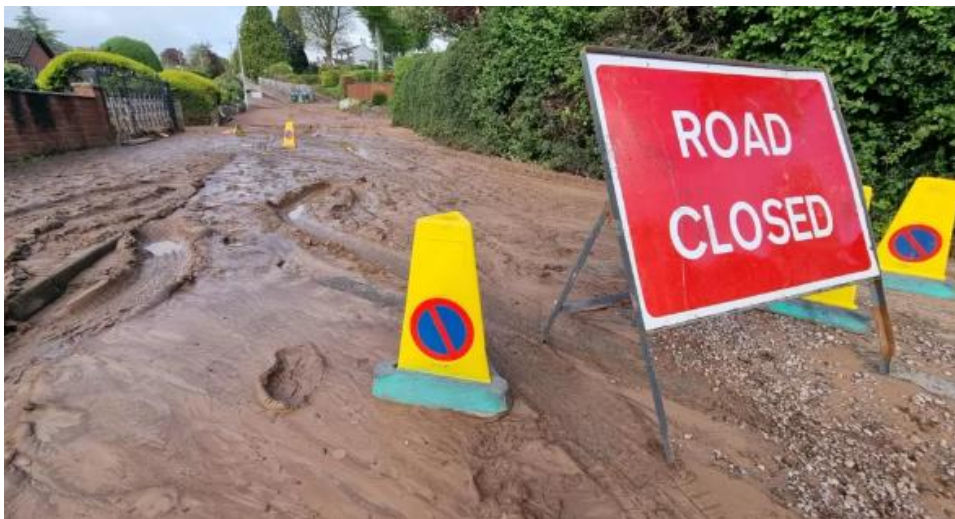
Figure 3.6 Road closed sign preventing access to Burrow Lane where soil and debris was deposited following the event. BBC News [Online] - Emotional rollercoaster since flash floods in Devon' - Accessed 4 September 2023 URL: <https://www.bbc.co.uk/news/articles/c3g9j4eyj0yo>)

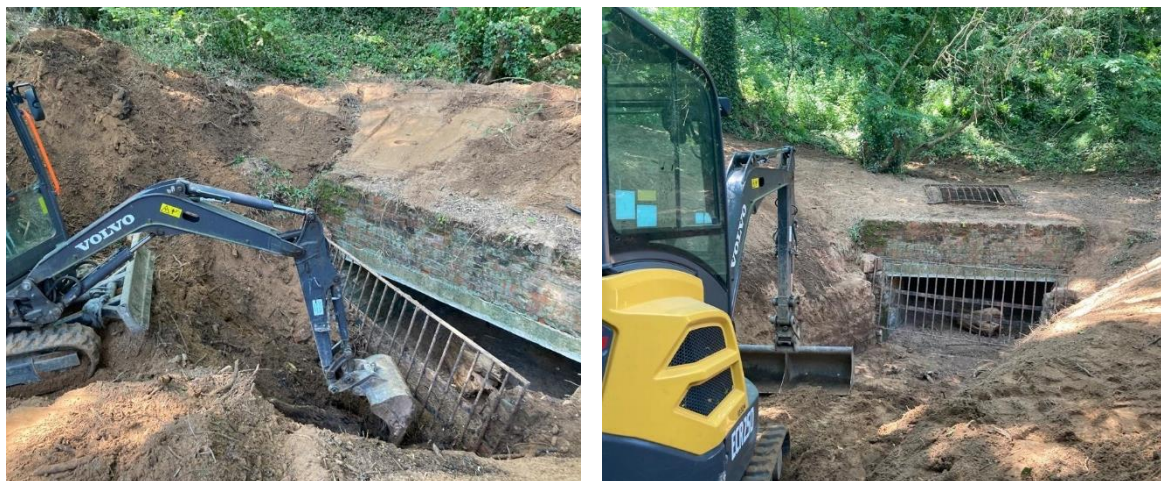
Figure 3.7 Clearance works at Tipton St John Sidmouth Rd culvert (Photo from DCC contractor)

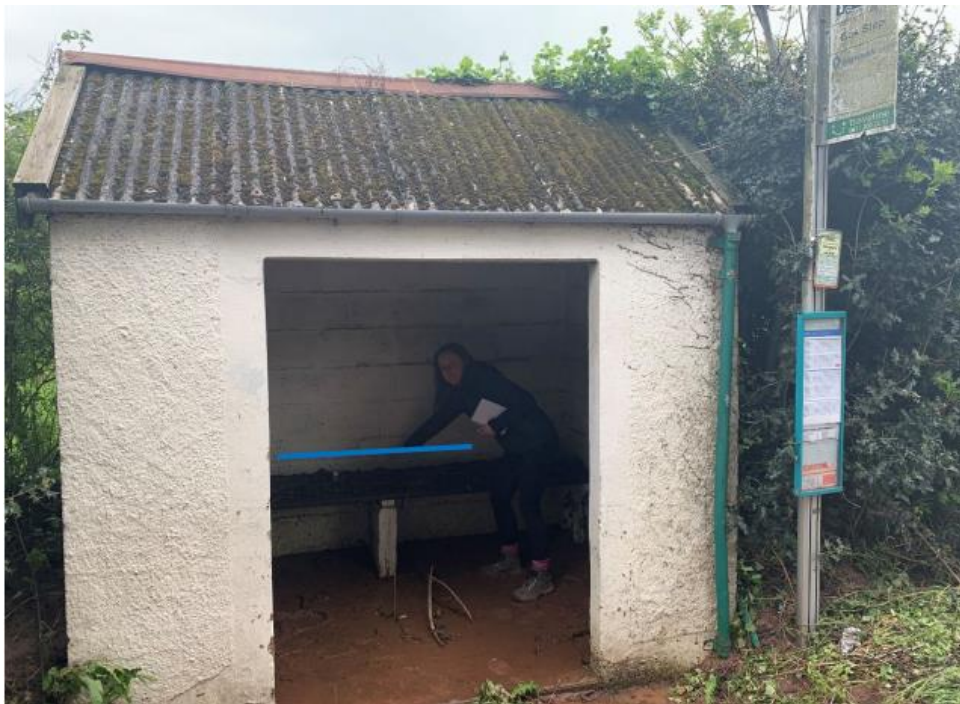
Figure 4.2 EA flood reconnaissance photo with EA staff/blue line marker highlighting the flood level reached on the bus stop at the end of Burrow, approximately Grid Reference: 307640, 089557.

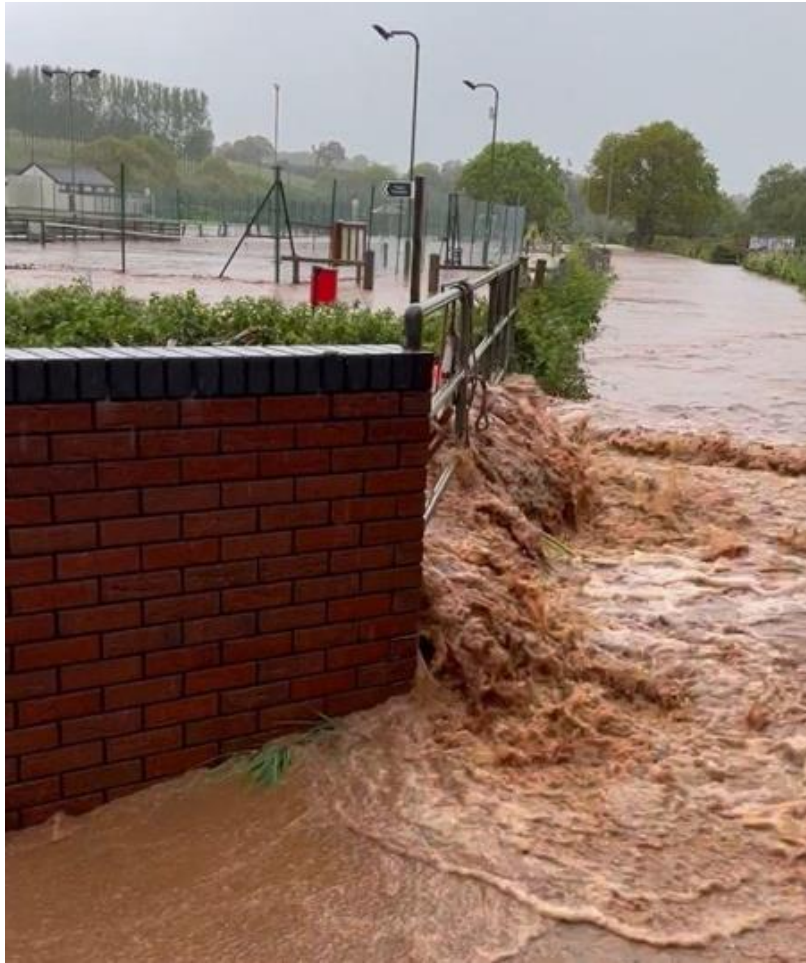
Figure 4.3 Still image taken from video post peak flows. This is looking north along Back Lane in Newton Poppleford before the Back Brook reaches the River Otter. Even following peak flows the bridge is shown as overtopping. (Resident's video submitted to EA/DCC).

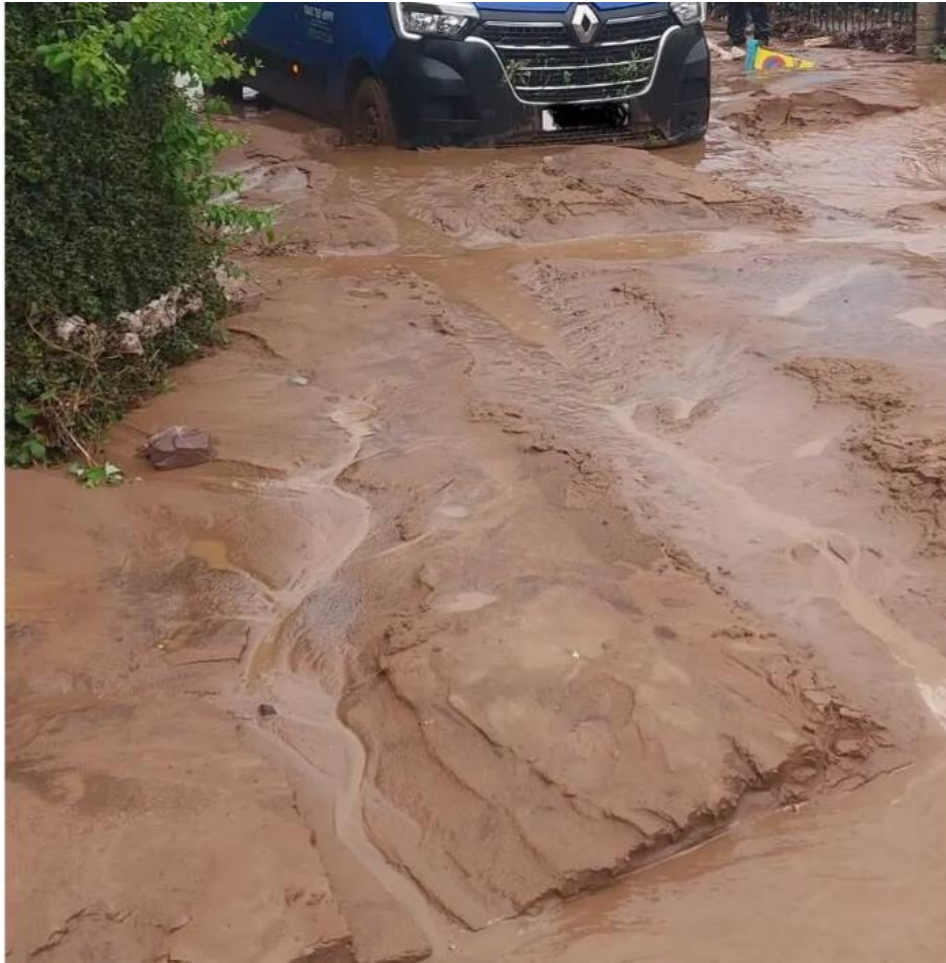
Burrow Lane experienced an isolated surface water flooding event. 15 properties were internally flooded in Burrow Lane. Burrow Lane residents experienced ingress of soil from the adjacent land with flood water depths of one to two inches internally for most of the affected properties rising to six inches in the worst affected. Multiple properties along the Northern edge of Burrow Lane were flow paths for water onto Burrow Lane and experienced damage to garden walls, banks and deposits of silt and material to significant levels.

Figure 4.5 Photo of silt deposit post event on Burrow Lane. East Devon News [Online] 'Flash floods turns East Devon roads to rivers' - Accessed 13 September 2023. URL: <https://eastdevonnews.co.uk/2023/05/10/east-devon-flood-photos-and-video/>

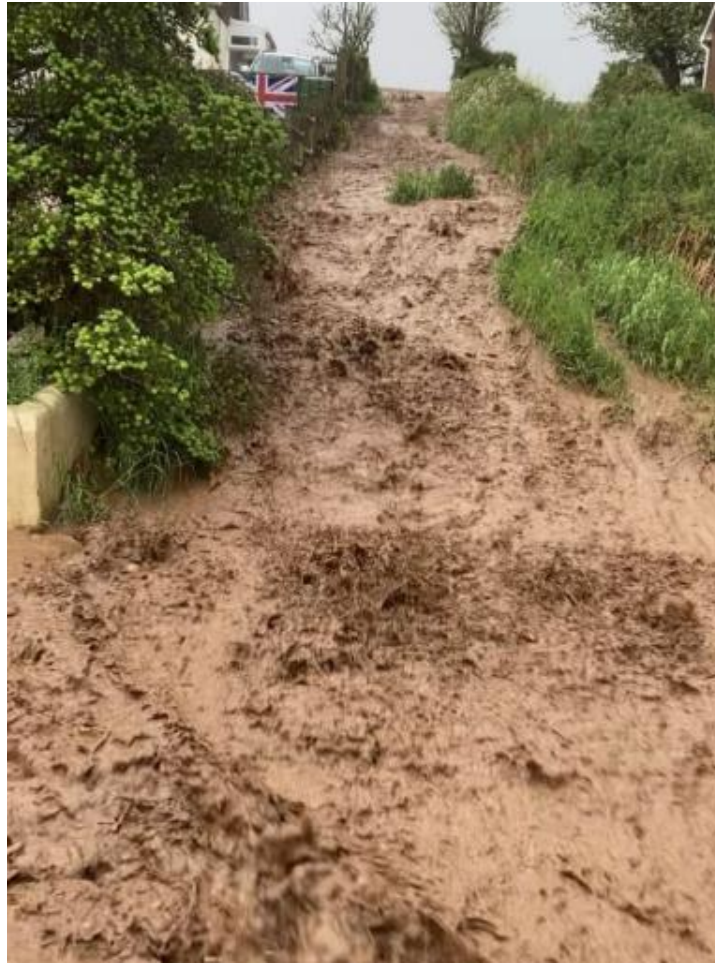
Burrow Lane experienced significant flows of sediment laden water from higher land to the north. Upslope fields had been sown with maize and EA assessments have adjudged that the main cause of runoff was due to heavy rain sealing the bare soil surface reducing porosity. This in turn led to surface saturation and rapid runoff down slope. In depth investigations here found that “there was no evidence of bad practice” but maize growing on three degrees slope or more can lead to excessive soil erosion and rapid runoff like that experienced in Burrow.

Figure 4.7 still image from video showing flows from adjacent agricultural land running down onto Burrow Lane via a field access (Resident's video submitted to EA/DCC).

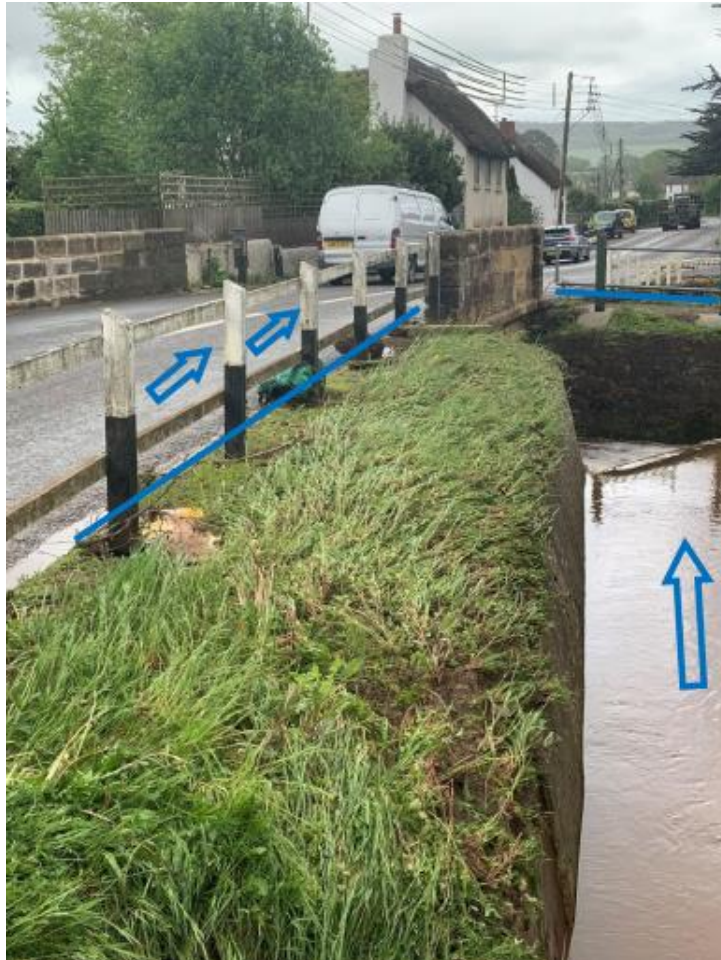
The Back Brook also led to flooding where flows backed up where it passes beneath the A3052 (Exeter Road) in Burrow, shown in Figure 4.8, flooding four commercial units up to eight inches internally. Residential properties along the Back Brook in Burrow on Exeter Road experienced internal flooding with depths of up to three foot deep for the worst affected.

Figure 4.8. EA recon photo showing flow paths marked by blue arrows and water levels marked by blue line at Burrow Bridge where it passes beneath the A3052, structure had inadequate capacity to cope with the May 9th event.

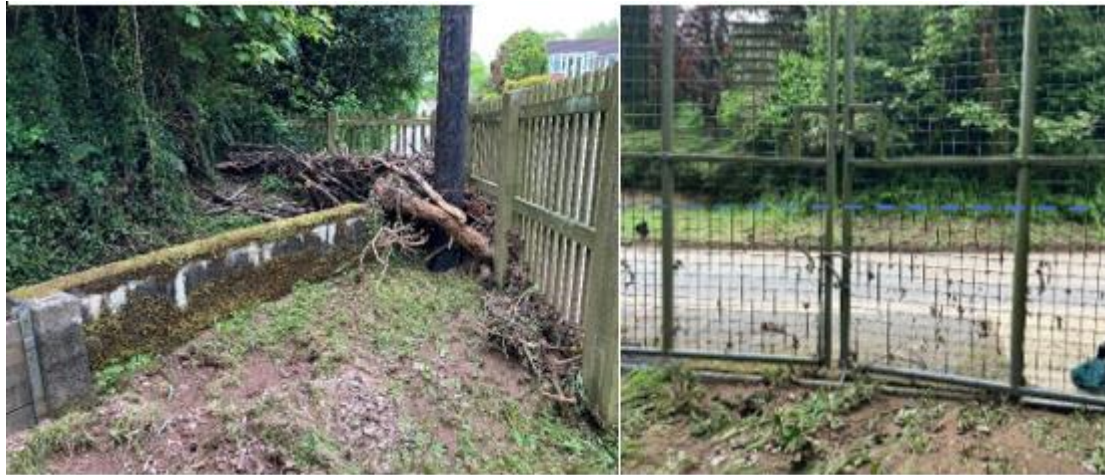
The main road through Tipton was recorded to have flooded around 2.15pm until 4.15pm at which point a sudden torrent came down the road between 4.15pm and 4.45pm. Blockage of the culvert near Ellacombe Cottages is thought to be a possible cause for this torrent. During which the millstream, which was not in spate as it's fed by the Otter, acted as an exceedance flow

Figures 4.10 and 4.11 Photo on left shows woody debris sat above the culvert inlet, post event. Photo on right shows access gate with padlock which had been forced open assumed due to the force of floodwater impounded by woody debris, both taken by EA during flood reconnaissance.

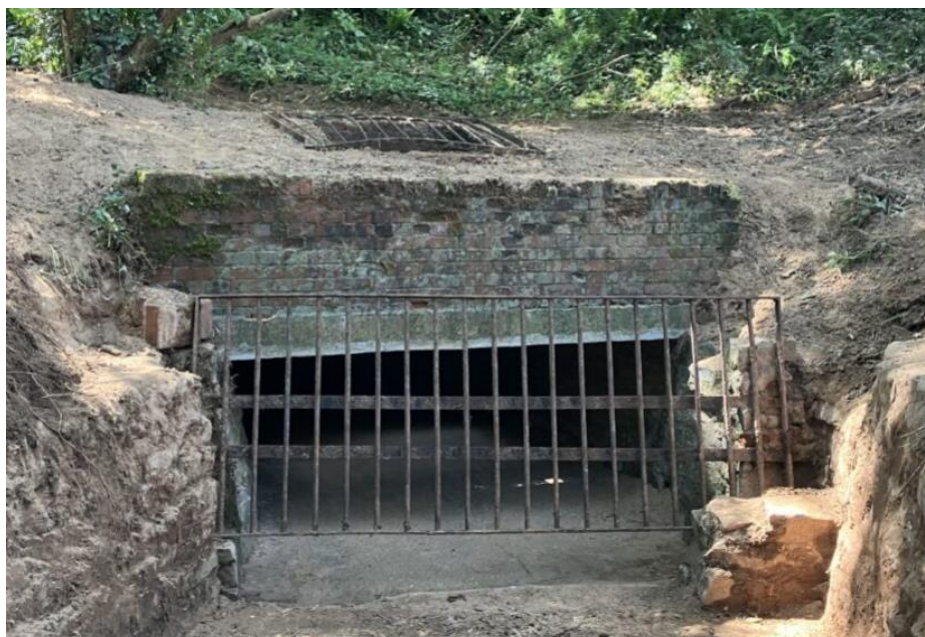
The culvert that runs under Sidmouth Road, shown in Figure 4.12, was post-event found completely buried in fine material and woody debris and the channel itself infilled. Highlighting the debris and material that the stream carried in this event. Landslips had occurred within the watercourse upstream of Sidmouth Road. It is possible that this area may have offered some informal online attenuation during peak flows, reducing flows downstream.

Figure 4.12 - Sidmouth Road culvert inlet in Tipton St John pictured following DCC clearance of structure which had been completely buried in fine sediment and woody material following the 9th May event, DCC recon photo.

Whilst clearance works of the channel and structures has been undertaken, the Environment Agency, with support of other relevant authorities, will consider options going forward to reduce the risk of flooding and of blockage to existing structures from the Coombe Stream.

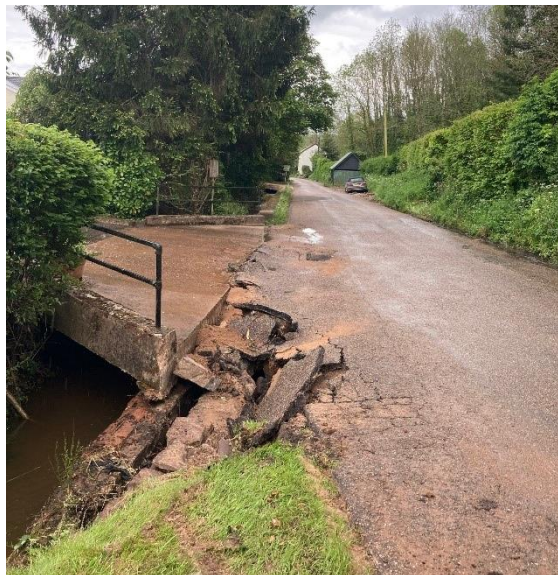
Figure 4.13 EA recon photo showing damage to the public highway along Brookvale at one of many points where flows came out of bank joining existing flows along the road network.

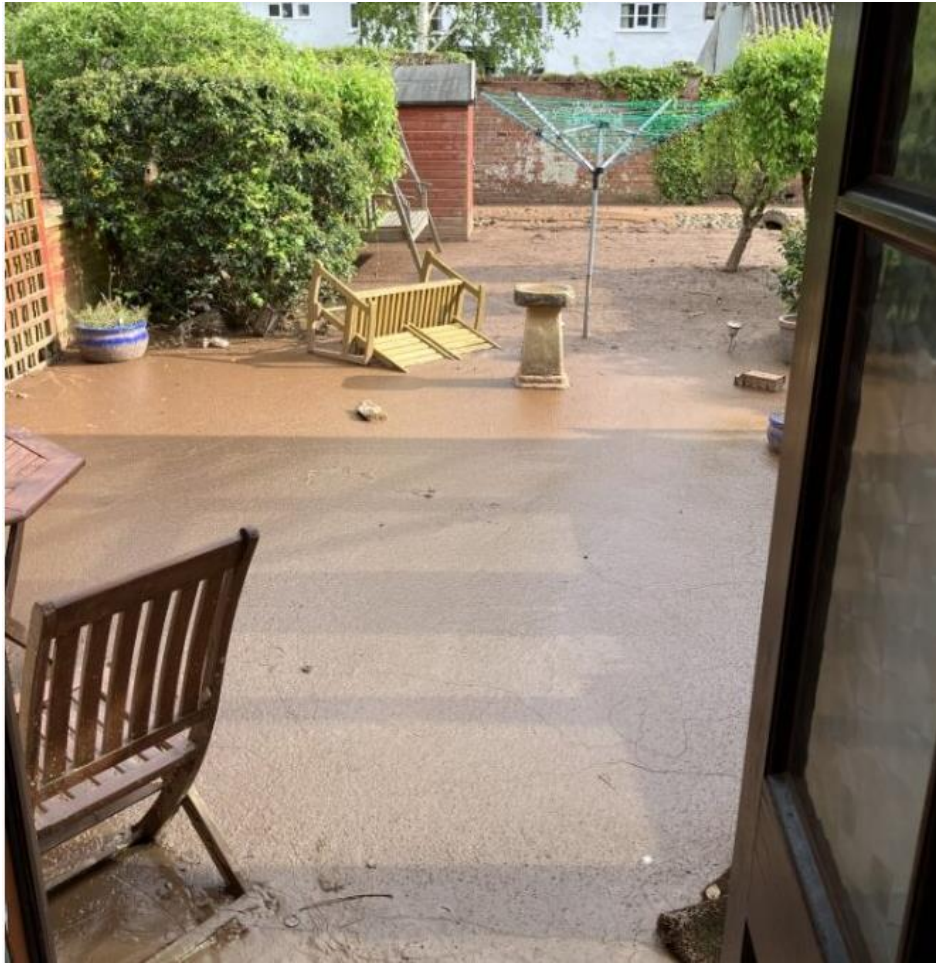
The road network along Lynch Head Road saw significant damage from surface water flows and overtopping of the watercourse in part due to heavily silt-laden flows. Residents in Venn Ottery were also left with extensive deposits of material in their property and external areas, shown in Figure 4.17.

Figure 4.17 DCC Flood Recon photo in Venn Ottery from 12 May 2023 showing silt deposits and damage to a residential garden.

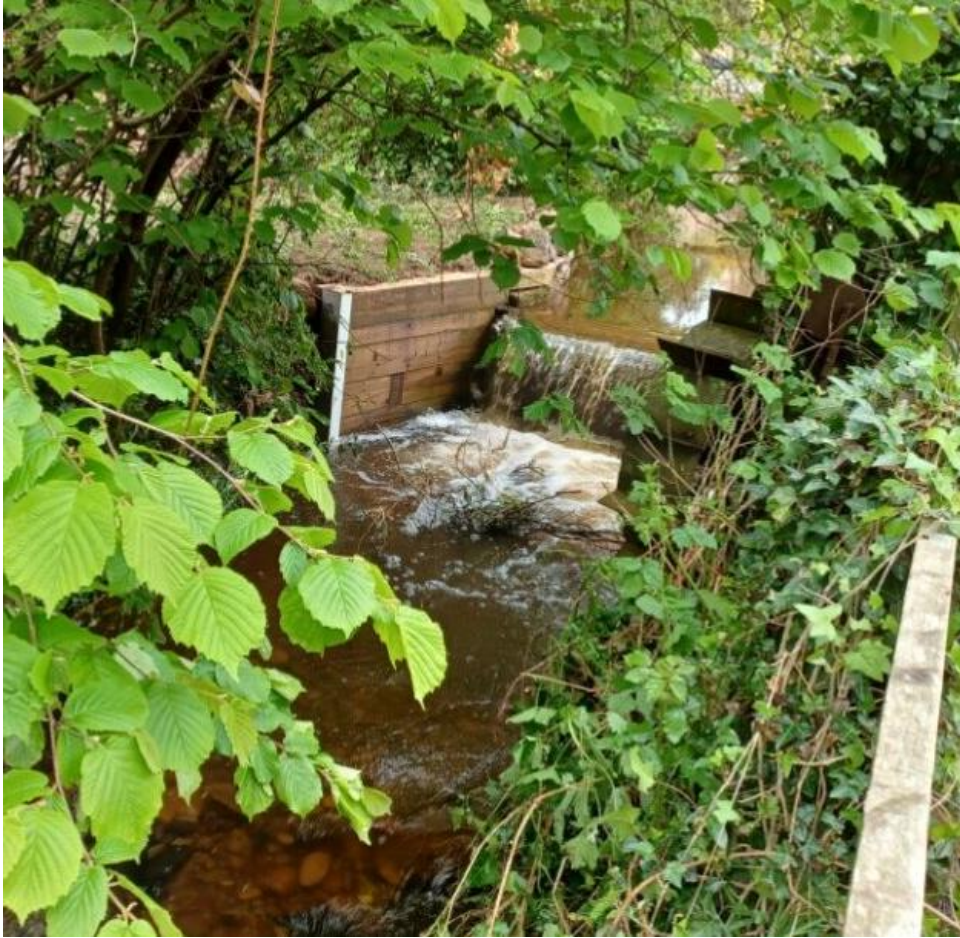
Figure 4.19 DCC Flood recon photo showing weir structure upstream of Exmouth Road, Colaton Raleigh

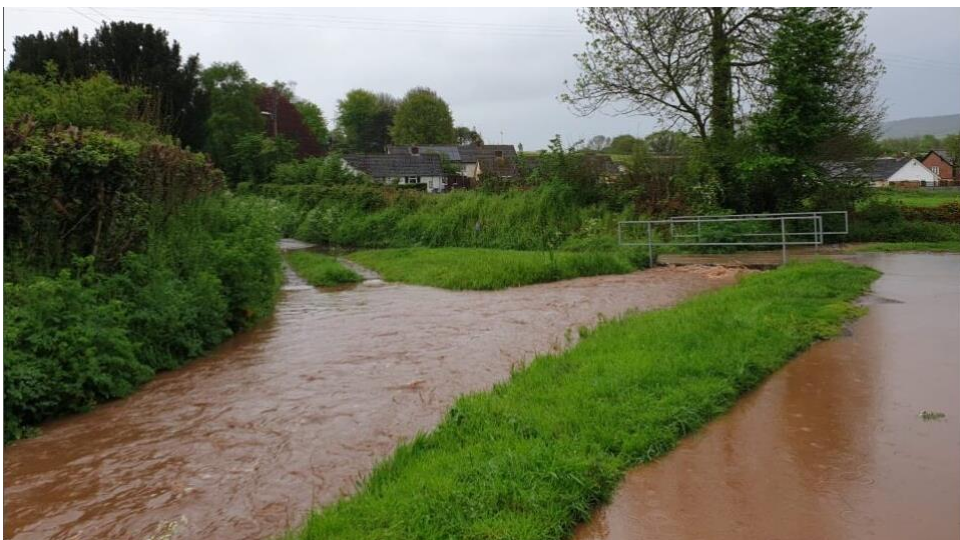
Two properties toward the eastern extent of Colaton Raleigh off Church Road were also flooded from the ordinary watercourse overtopping which was overtopping on both banks. At Brook Lane flood depths affecting the ford and lane itself were significant due in part to reduced channel capacity.

Figure 4.20 Brook Lane Ford in flood during the incident (Resident's photo submitted to EA/DCC)

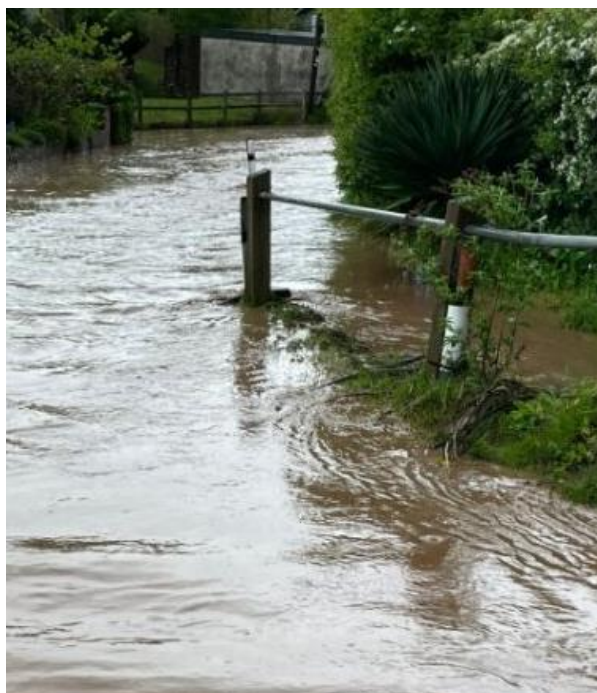
Figure 4.21 Out of bank flows onto Lower Way, Harpford on 9 May 2023 (Resident's photo submitted to EA/DCC).

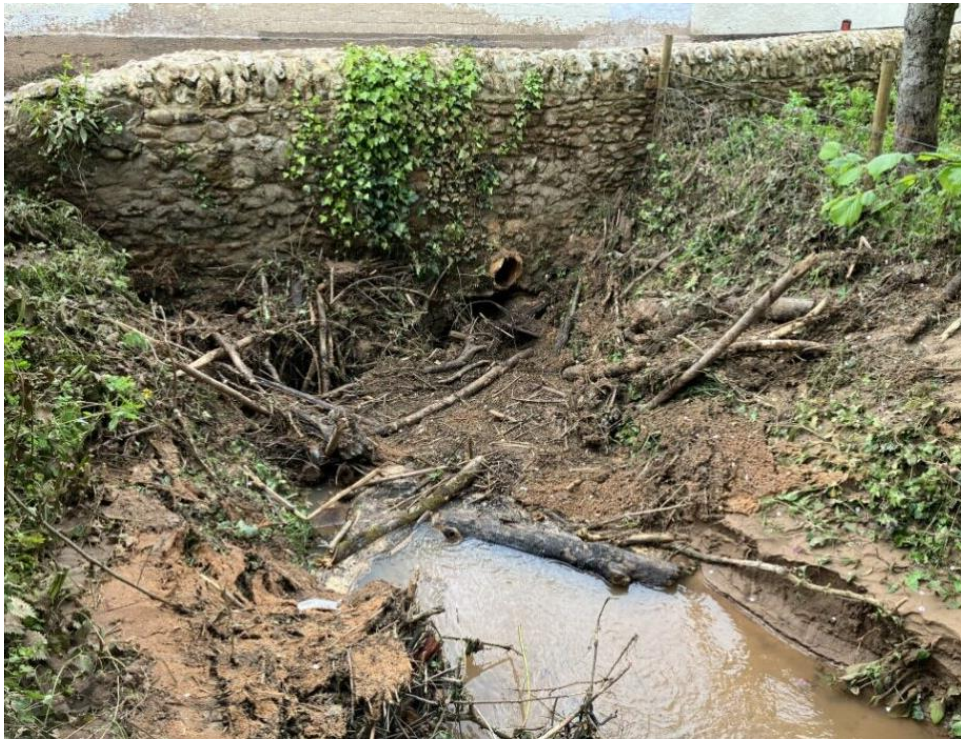
Figure 4.22 DCC Flood Recon photo showing Higher Way culvert on 10 May 2023 partially blocked even after significant clearance works

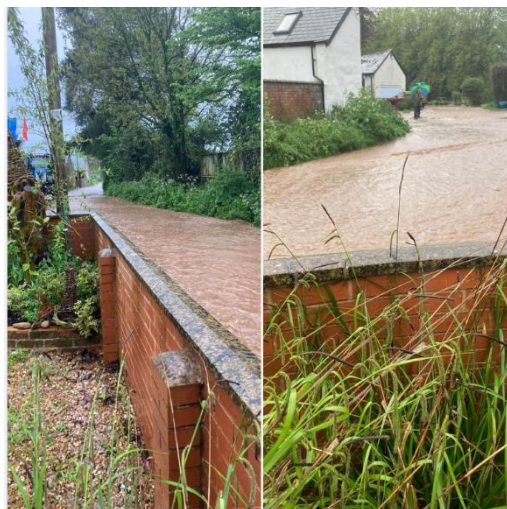
Fluxton: Just outside of Tipton St John, two properties in Fluxton were flooded from the ordinary watercourse that flows through the hamlet and surface water flows from surrounding land. See Figure 4.23. Both properties have been previously flooded and have been offered property level protection through DCCs countywide funding scheme.

Figure 4.23. Flooding scenes at Fluxton on 9th May 2023 (Resident Photo submitted to DCC)

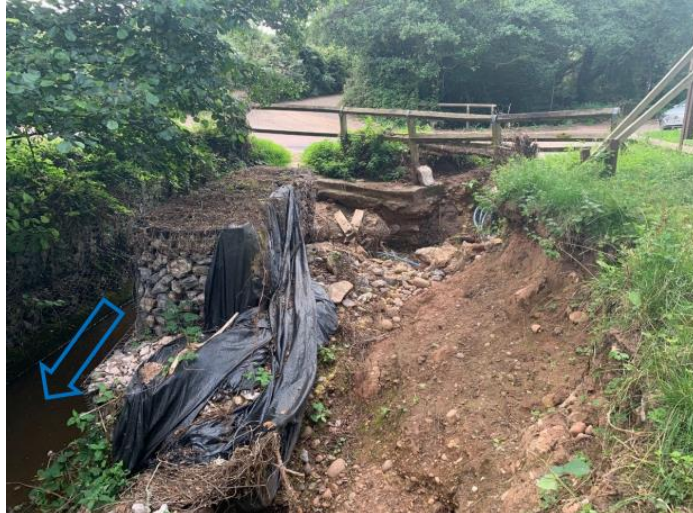
In addition to this, significant damage was caused to a bridle way which crosses the watercourse. Culverts along the Back Brook were damaged and blocked during the event most significantly at Hawkerland Cross. Significant repair works to the culvert and the adjacent bank of the watercourse has been designed and planned for repair this Autumn/Winter by the DCC Structures Team.

Figure 4.24. EA Flood recon photo showing damage to watercourse and existing gabions at Stoneyford with blue arrow showing flow path

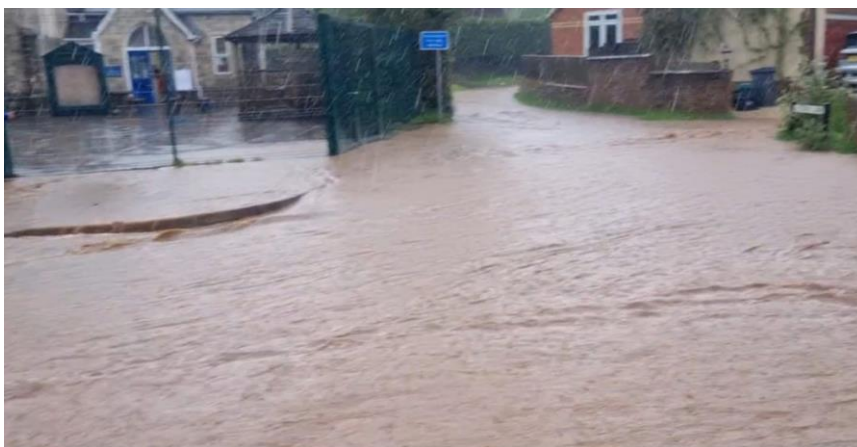
In the Main village, no properties were affected internally. The local school grounds however were flooded, where an undersized culvert by the school caused flows to go on to the road. This caused difficulties for access to the primary school during the event (see Figure 4.25). Exceedance flows then ran down the road where they re-joined the watercourse at Honey Lane via a Highways drainage ditch.

Figure 4.25 Photo showing surface water flows and ordinary watercourse overtopped outside Woodbury Salterton Primary School on 9th May 2023, Resident's photo submitted to East Devon District Council/DCC.

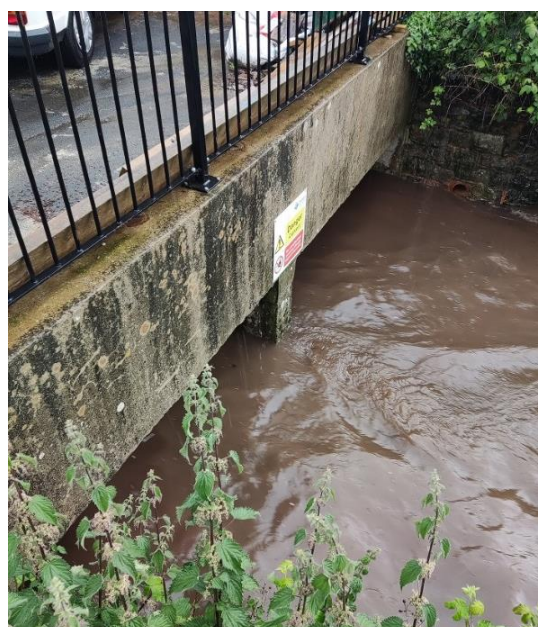
On Honiton Road at the bottom of Quarry Lane, the Northbrook watercourse is culverted underneath Honiton Road. It is believed that excessive surface water flows overwhelmed the highway drainage here and were unable to get into the watercourse. This caused significant ponding in the area resulting in a road closure and internal flooding to four properties. The fire service was in attendance during the incident to pump water out from properties. All highway assets have been mapped and cleaned as necessary since the flood event.

Figure 4.27. Northbrook watercourse entering the culvert underneath Honiton Road can be seen to still have some capacity during the flood event (Photo DCC)

Devon County Council are now proceeding with modelling the Northbrook watercourse at this location including the highway drainage to look at possible improvement works.
