Flood Investigation Report

Otter Valley Floods 9 May 2023

(Including all reported flooding within the County on this date)

This flood investigation report has been produced by Devon County Council as a Lead Local Flood Authority under Section 19 of the Flood and Water Management Act 2010.

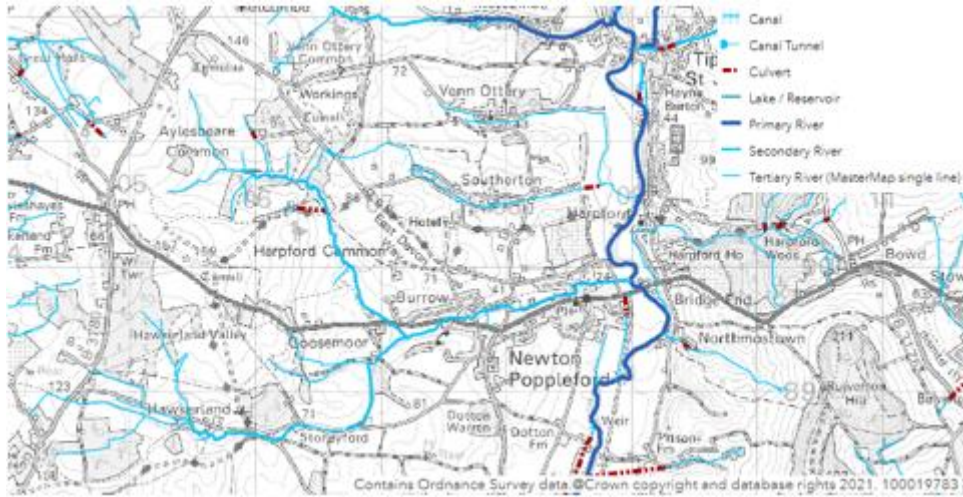
Figure 4.1 OS greyscale map with watercourses highlighted showing points of confluence for tributaries of the Back Brook upstream of Newton Popleford

The most widespread flooding on the Back Brook was seen in the downstream reaches of the Back Brook after the two tributaries join east of Goosemoor, see Figure 4.1, and enters the more urbanised areas of Burrow and Newton Poppleford.

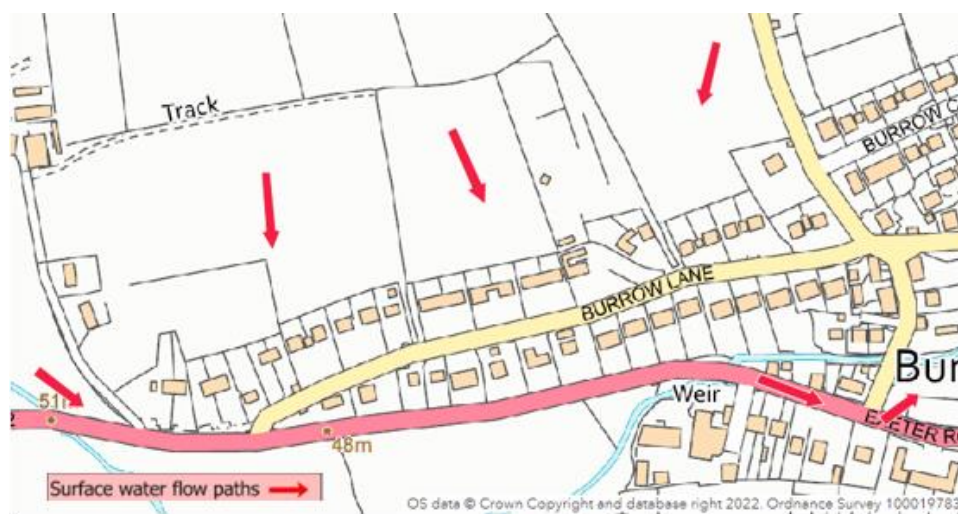
Figure 4.4 OS map marked to show the flow paths experienced in Burrow on 9 May 2023

Burrow Lane experienced an isolated surface water flooding event. 15 properties were internally flooded in Burrow Lane. Burrow Lane residents experienced ingress of soil from the adjacent land with flood water depths of one to two inches internally for most of the affected properties rising to six inches in the worst affected. Multiple properties along the Northern edge of Burrow Lane were flow paths for water onto Burrow Lane and experienced damage to garden walls, banks and deposits of silt and material to significant levels.

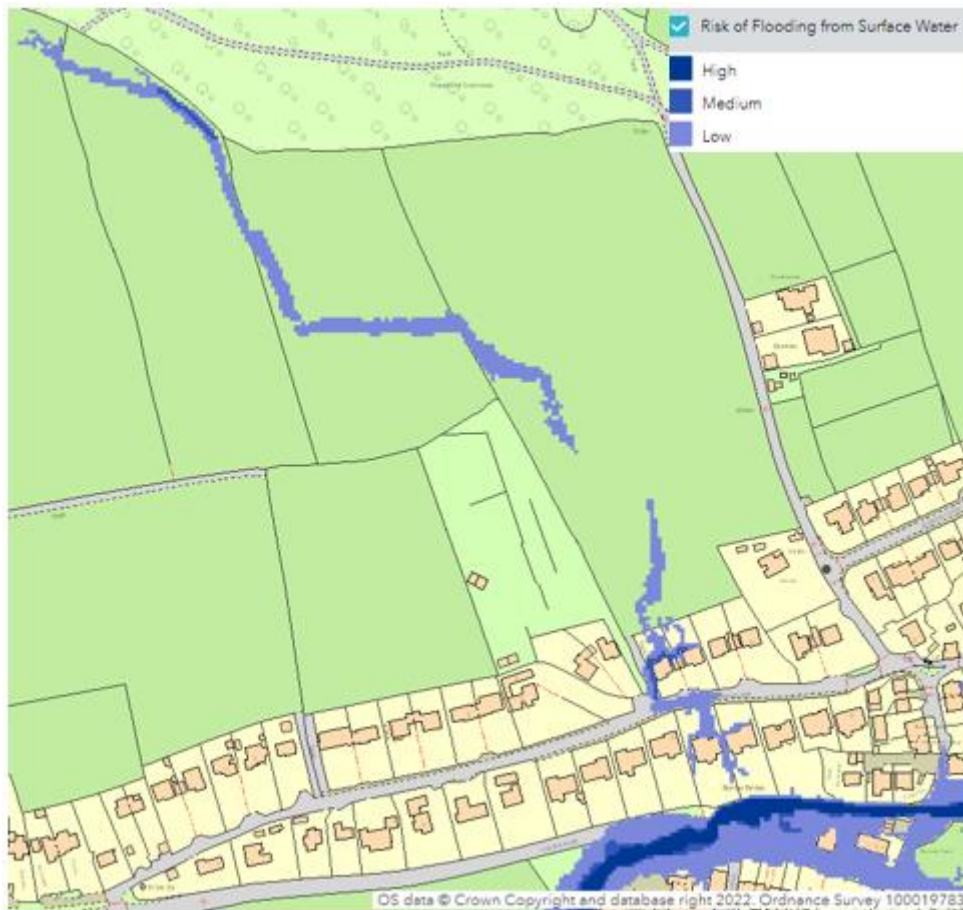
Figure 4.6 OS map of national surface water flood risk in Burrow Lane

The surface water flows onto Burrow Lane during the event were not as the national surface water flood mapping suggests (shown in figure 4.6 below). Accesses to agricultural land acted as major flow paths as well as flows direct into rear gardens where rear walls and banks collapsed due to heavily soil laden flows. Updates to the flood risk mapping in Burrow Lane may be necessary in the longer term.

Burrow Lane experienced significant flows of sediment laden water from higher land to the north. Upslope fields had been sown with maize and EA assessments have adjudged that the main cause of runoff was due to heavy rain sealing the bare soil surface reducing porosity. This in turn led to surface saturation and rapid runoff down slope. In depth investigations here found that “there was no evidence of bad practice” but maize growing on three degrees slope or more can lead to excessive soil erosion and rapid runoff like that experienced in Burrow.

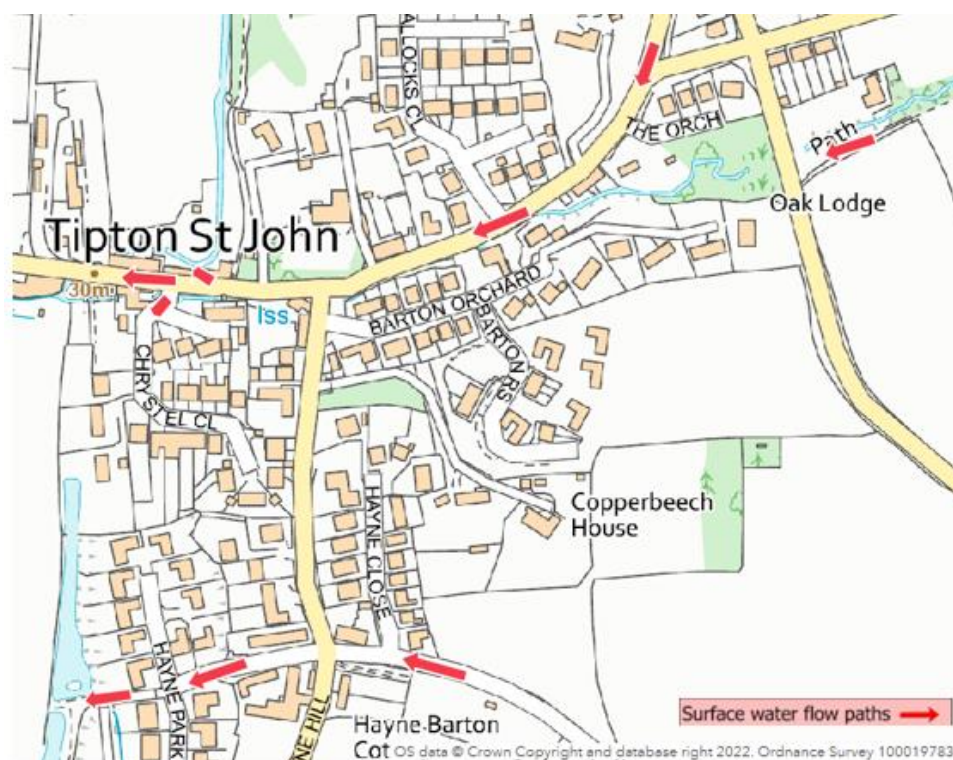
Figure 4.9 OS Map showing flow paths, marked by arrows, of surface water and Coombe Stream through Tipton St John during event

Tipton St John experienced significant flooding due to heavy rainfall leading to surface water flows from East Hill and Coombe channelled down into the village, as well as into the Coombe Stream.

The main road through Tipton was recorded to have flooded around 2.15pm until 4.15pm at which point a sudden torrent came down the road between 4.15pm and 4.45pm. Blockage of the culvert near Ellacombe Cottages is thought to be a possible cause for this torrent. During which the millstream, which was not in spate as it's fed by the Otter, acted as an exceedance flow

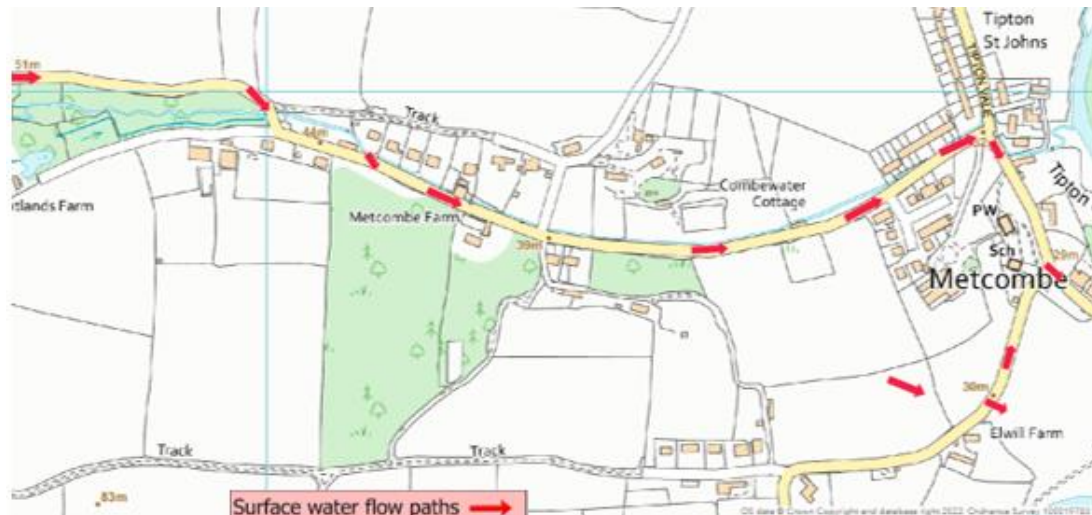
Figure 4.14 OS map showing flow paths during event in Metcombe marked by arrows.

The local primary school experienced significant impacts with a classroom flooded and pupils having to spend weeks learning in the nearby village hall setup as alternative accommodation.

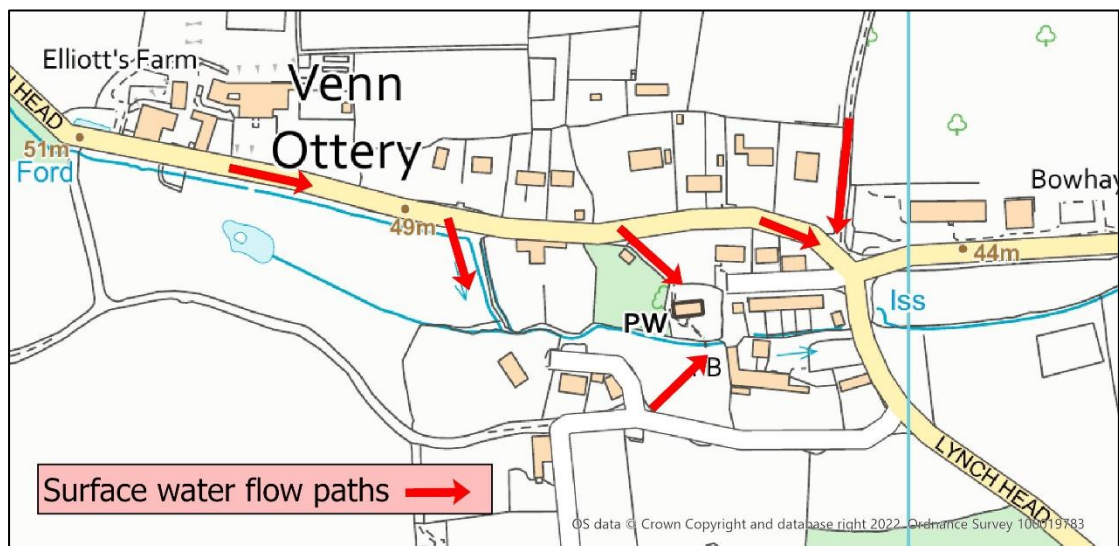
Figure 4.15 OS Map showing the flow paths experienced in Venn Ottery on 9 May 2023

In Venn Ottery, nine properties were internally flooded. The mechanism for flooding and flow paths of floodwater were very similar to those recorded for the 2008 flood incident in the village.

Upstream of Venn Ottery there is an informal ford crossing at which point flows in the watercourse are unconstrained and therefore, during larger incidents can easily end up flowing down the road network before re-entering the watercourse. The watercourse, as it flows past the church, contains informal structures that impacted upon flows. A cattle grid type culvert, private bridges and a brick wall all pose obstructions to flow. The EA have discussed with a resident regarding the removal of an existing structure which impacts upon exceedance flows along the watercourse. DCC and the EA have spoken with upstream and downstream landowners regarding riparian responsibilities and land management.

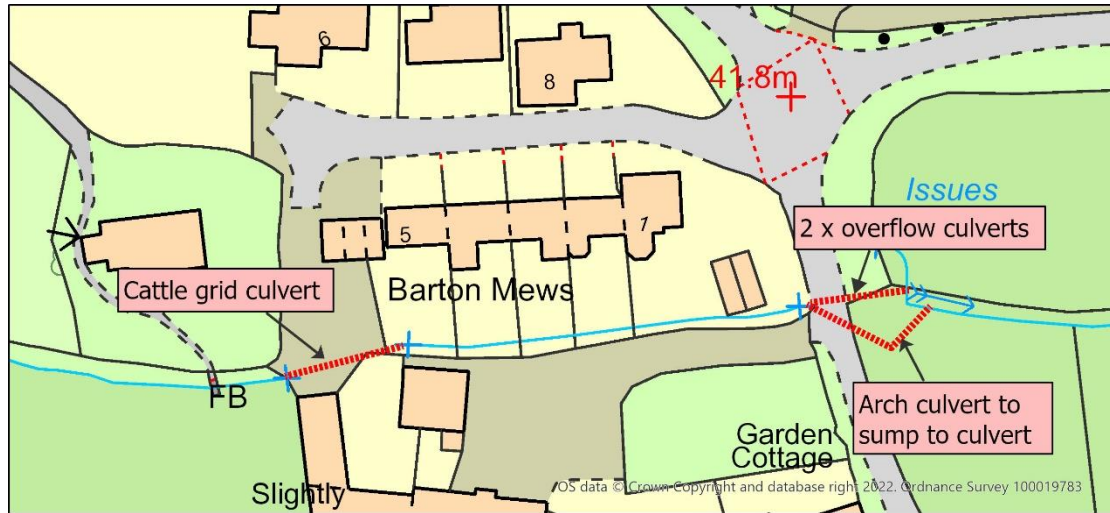
Figure 4.16 OS Map showing structures on the watercourse that exist within Venn Ottery

There is a final constraint upon flows where there is an old arch culvert which runs at a dogleg under Lynch Head, and outfalls into an informal sump before

culverted again back into the watercourse. The informal sump which is exposed is believed to have been completely buried with vegetation and debris during the event limiting flows from passing under the arch culvert, whilst the overflows that run directly into the watercourse were also blocked, shown below.

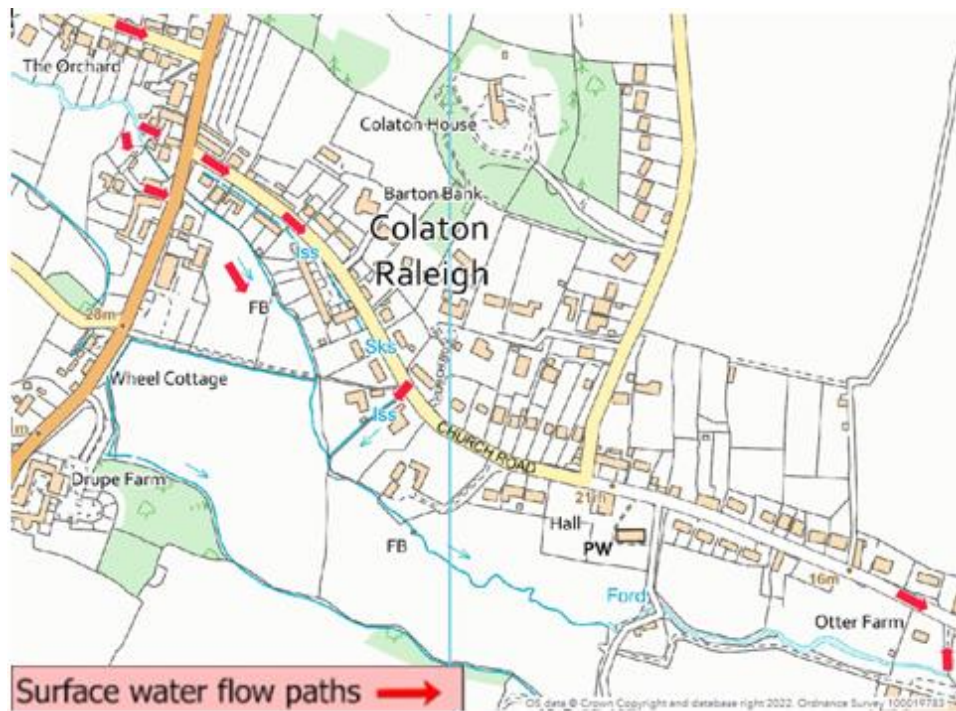
Figure 4.18 OS Map showing flow paths in Colaton Raleigh during the incident

Eight properties in Colaton Raleigh were flooded internally with a handful of others experiencing near misses. Five properties of the eight were flooded west of Exmouth Road and an external outbuilding damaged as well.

The largest event in recent memory for the village was in November 2012. In that event the Exmouth Road culvert's parapet walls exacerbated the flooding experienced, since which these were removed and letterbox openings created in the wall to allow flows back into the watercourse. In May 2023 flows were however, found to be out of bank upstream of the Exmouth Road culvert during the event, in part due to the sheer volume of water but also impacted by an unconsented in channel weir type structure where flows came out of bank immediately upstream. This is believed to have been introduced since 2012 and means the right hand bank (looking downstream) is little more than 200mm in height.

As the watercourse overtopped and flowed onto Exmouth Road it merged with surface water flows and continued down Church Road until rejoining downstream of the play park following the route of the Church Road leat.

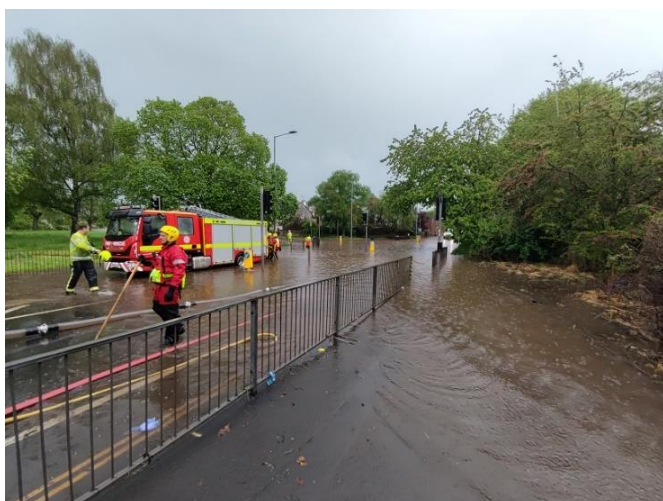
On Honiton Road at the bottom of Quarry Lane, the Northbrook watercourse is culverted underneath Honiton Road. It is believed that excessive surface water flows overwhelmed the highway drainage here and were unable to get into the watercourse. This caused significant ponding in the area resulting in a road closure and internal flooding to four properties. The fire service was in attendance during the incident to pump water out from properties. All highway assets have been mapped and cleaned as necessary since the flood event.

Figure 4.26. Fire service in attendance at the bottom of Quarry Lane (Photo DCC)

Devon County Council are now proceeding with modelling the Northbrook watercourse at this location including the highway drainage to look at possible improvement works.
